SUBJECT: Site Inspection, Quality Building Stone, Italian Tan Quarry,  
S/007/038, Carbon County, Utah

Date of Inspection: May 10, 2004  
Time of Inspection: About 3:15-3:45 p.m.  
Conditions: Mostly clear, windy, 70's  
Participants: Paul Baker, DOGM

S/007/038, Italian Tan Quarry, Quality Building Stone

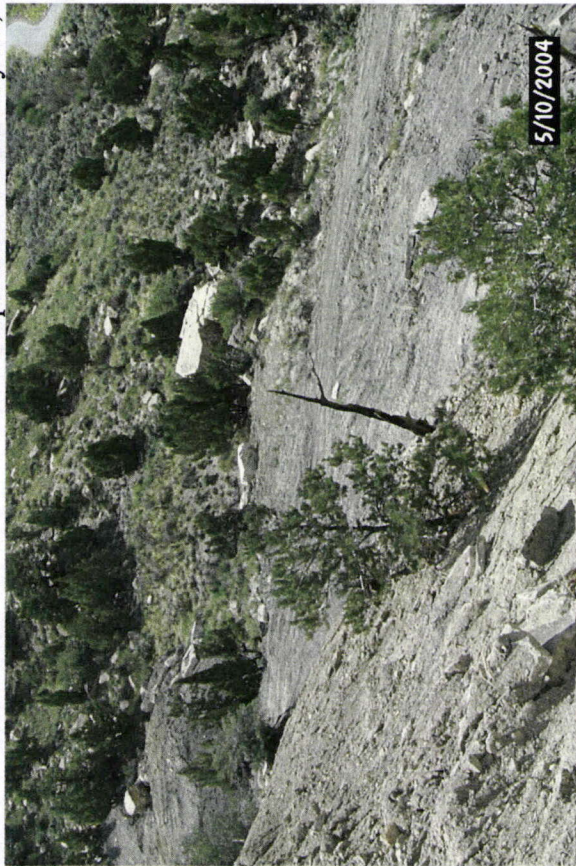
The site consists of a crossing over Hardscrabble Creek and a road that switches back up the side of the hill. There are a few wide spots in the road, such as the area near the center of Photo 1, and there is also at least one side road. Material from building the road was sidecast down the hill.

There was one pile of material that might be soil, but I otherwise saw no sign that soil had been saved.

Any soil has already been either sidecast or compacted, so I don't know how it would be possible to save it.

Photo 1. A portion of the disturbance midway up the hill. The road up Hardscrabble Canyon is in the extreme upper right of this photo.

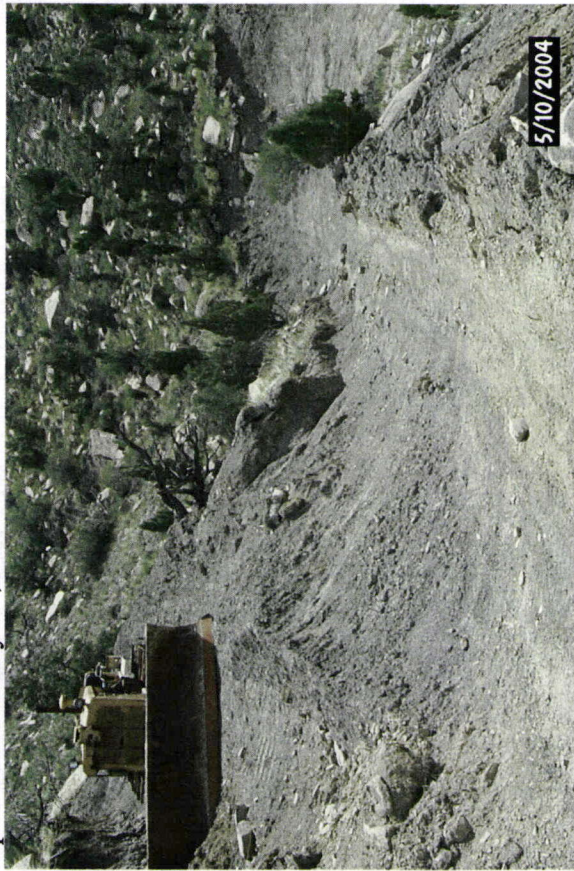
Photo 2. This photo is of an area near the top of the disturbance.

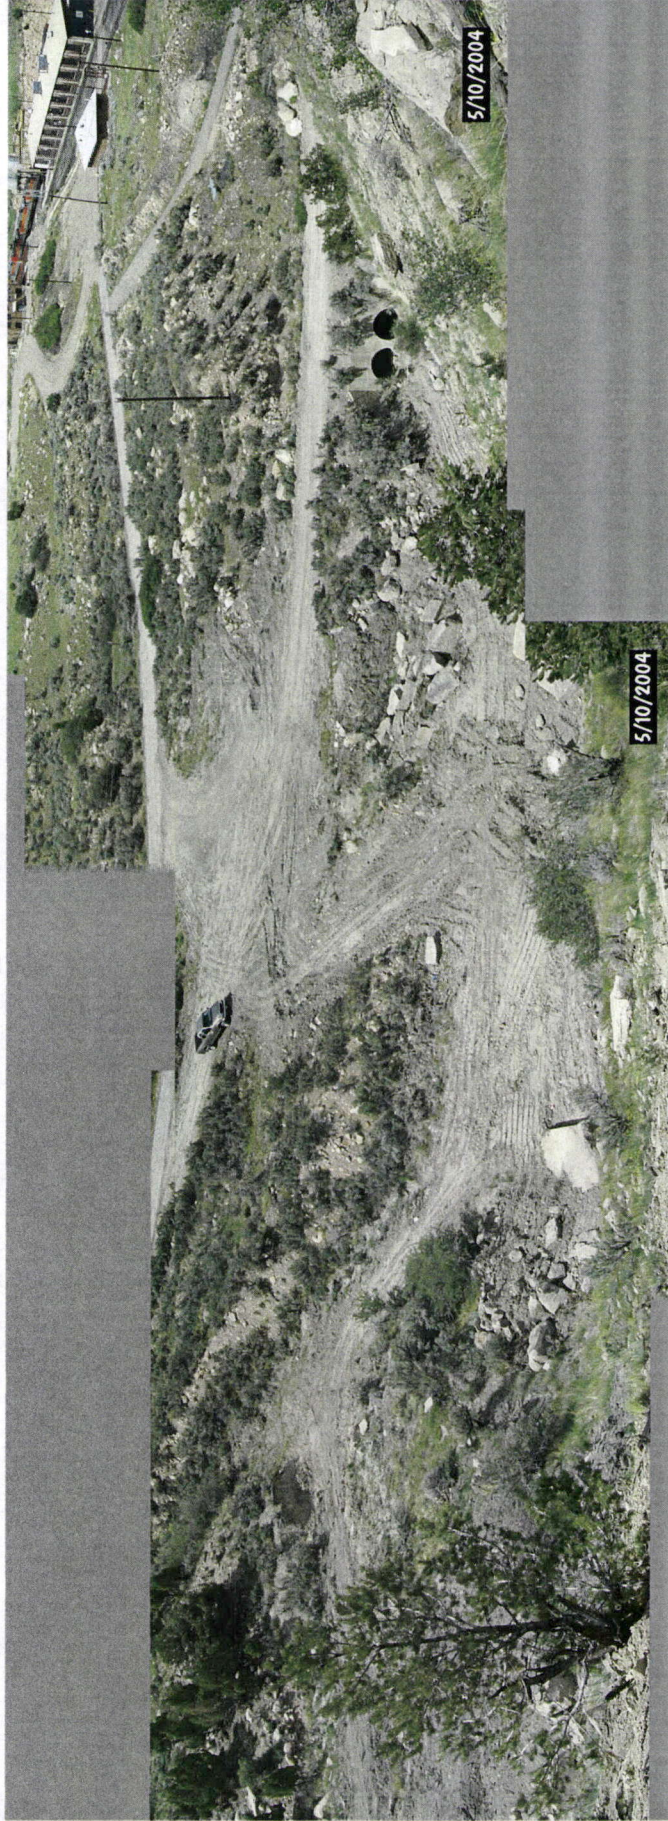
Although the bottom of the ephemeral stream channel has been disturbed, no sediment control measures were employed. This channel sometimes carries water in the spring and late summer, and it is not far from the Price River.

**Photo 3. Panorama of the crossing through Hardscrabble Creek (ephemeral stream) and the lower part of the disturbed area. In the upper right is Utah Railway's Martin Locomotive Yard.**

Although Hardscrabble Creek is ephemeral, there is enough disturbance in the creek bed itself and in areas immediately adjacent to the creek that some form of sediment control is appropriate. If the operator is going to continue operations in this area, a culvert crossing should be installed, and berms and silt fences should be placed to treat water coming off the site.

The Division needs to issue a notice of noncompliance requiring the operator to complete the NOI and submit a reclamation bond. The Division should also consider requiring the operator to do some of the sediment control discussed above.
